KEUKA LAKE OUTLET DAM

**. YATES COUNTY, NEW YORK
INVENTORY NO. N.Y. 390**

**PHASE I INSPECTION REPORT
NATIONAL DAM SAFETY PROGRAM**

AUGUST 1980

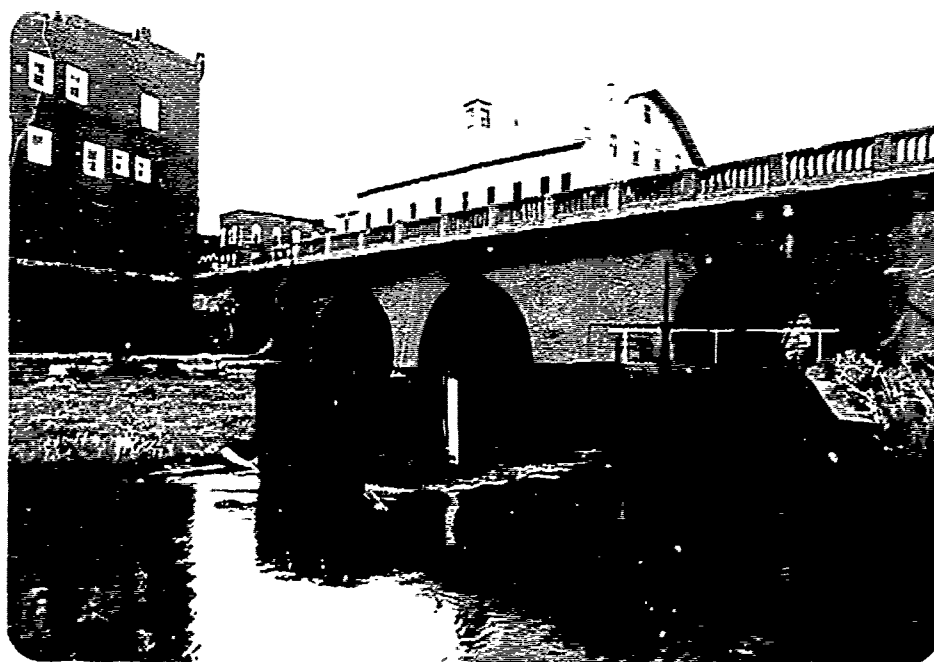
Visual observations of the dam did not reveal any serious deficiencies which would affect the stability of the dam. There was a small amount of scour behind the upstream ends of the sheet piling and one of the concrete posts supporting the gate mechanism at the northern end of the dam was deteriorated. A small amount of leakage exiting at the base of the masonry wall was observed in a prior inspection. With the exception of these deficiencies, the dam appeared to be structurally in good condition

Entrance Channel to Southern Service Spillway
Note Erosion Behind End of Sheet Piling

1. Repair the concrete on the post supporting the northern slide gate control mechanism.
2. Fill the small scoured areas behind the sheet pile walls and protect this area with riprap.
3. Monitor the leakage in the masonry wall and if it becomes worse, take remedial actions.
4. Remove the debris which has accumulated in the vicinity of the northern spillway gates.
5. Cut trees and brush which line the channel in the vicinity of the dam.
6. Develop and implement a detailed emergency operation-action plan and warning system.

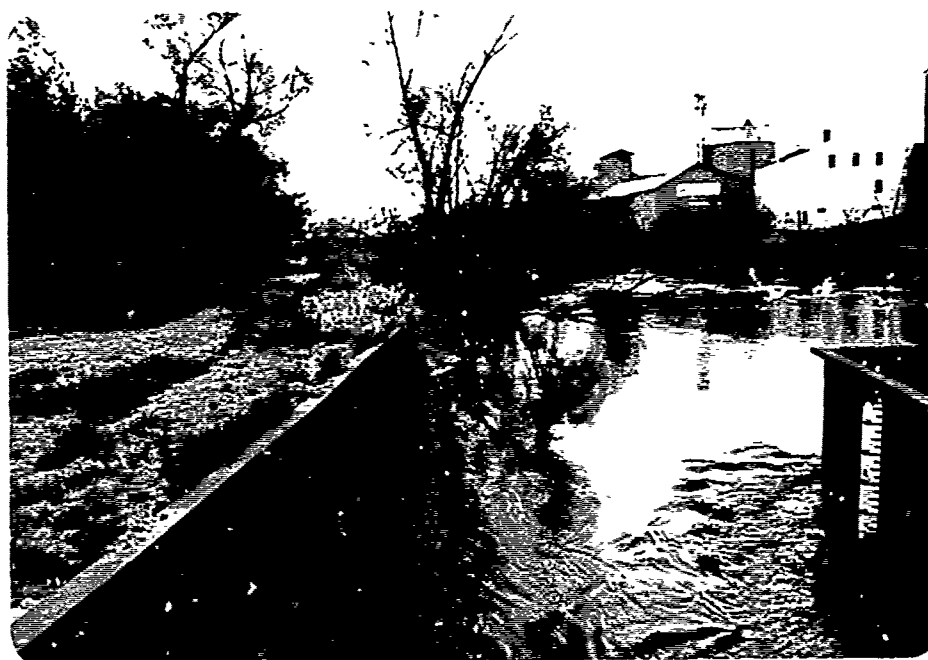
Entrance Channel Looking Upstream-Note trees
Hanging Over Approach Channel

- a. Slopes KEUKA LAKE & OUTLET CHANNEL - BRUSH & TREES GROWING ALONG CHANNEL SHOULD BE CUT TO REDUCE DEBRIS PROBLEM
- b. Sedimentation _____
- c. Unusual Conditions Which Affect Dam NARROW CHANNEL TO DAM RAILROAD BRIDGE UPSTREAM COLLECTS DEBRIS & POUNDS SOME H₂O.

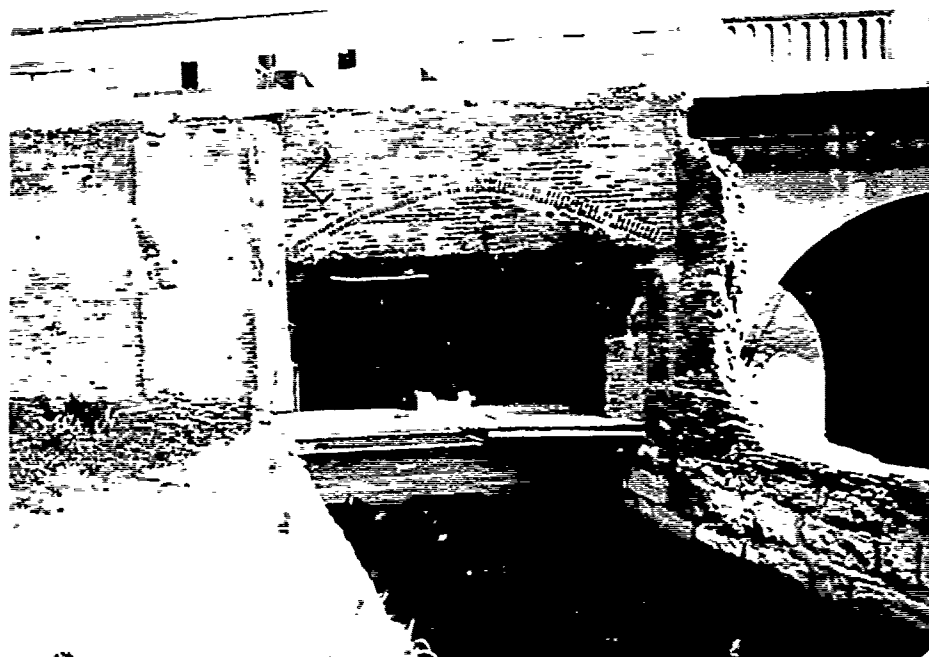
The slide gate on the northern end was very old but appeared to be operational. The gate control mechanism was supported on four concrete posts at its corners. The concrete on the left front post was deteriorated and partially removed. Further loss of concrete on this post could result in the gate becoming inoperable. The northern bank of the approach channel to this spillway is lined with gabions and riprap. This bank appeared to be in satisfactory condition.

Northern Service Spillway-Birkett Gate

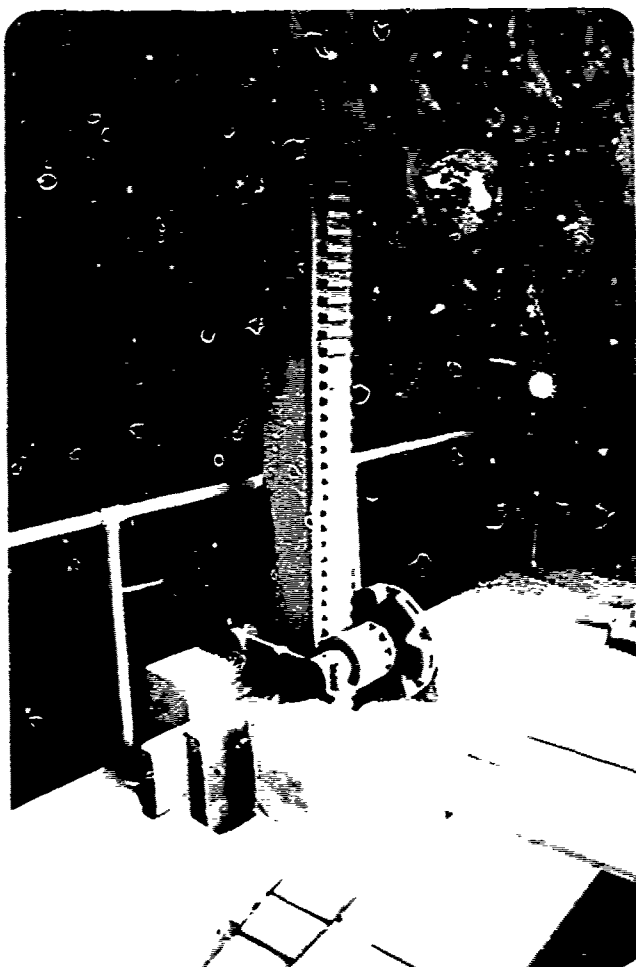
Control Mechanism For Birkett Gate

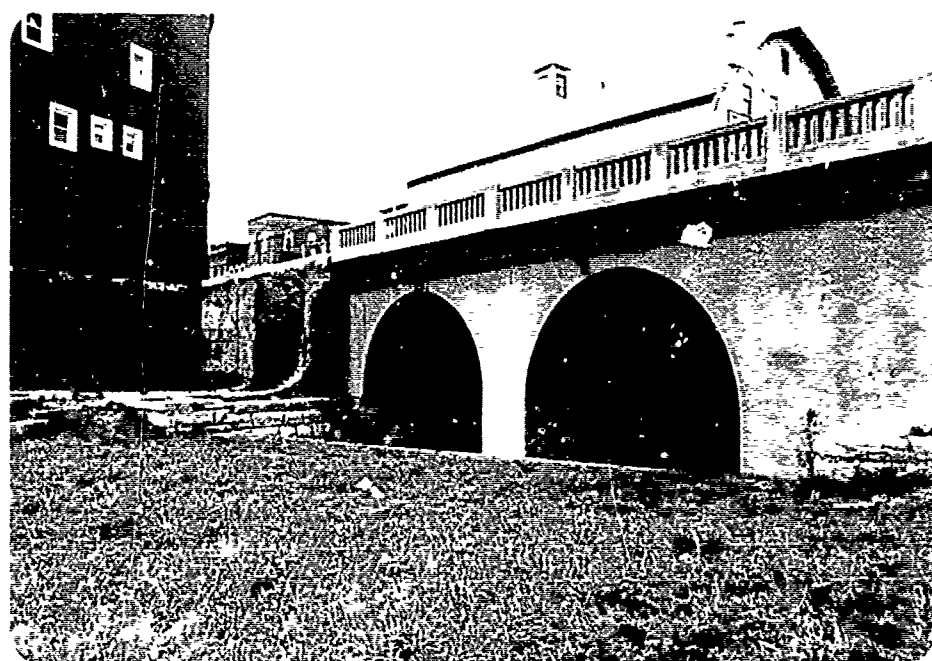
The auxiliary spillway is formed by the center portion of the dam. It appeared to be in satisfactory condition.

Auxiliary Spillway Channel with Earth Fill on Upstream Slope

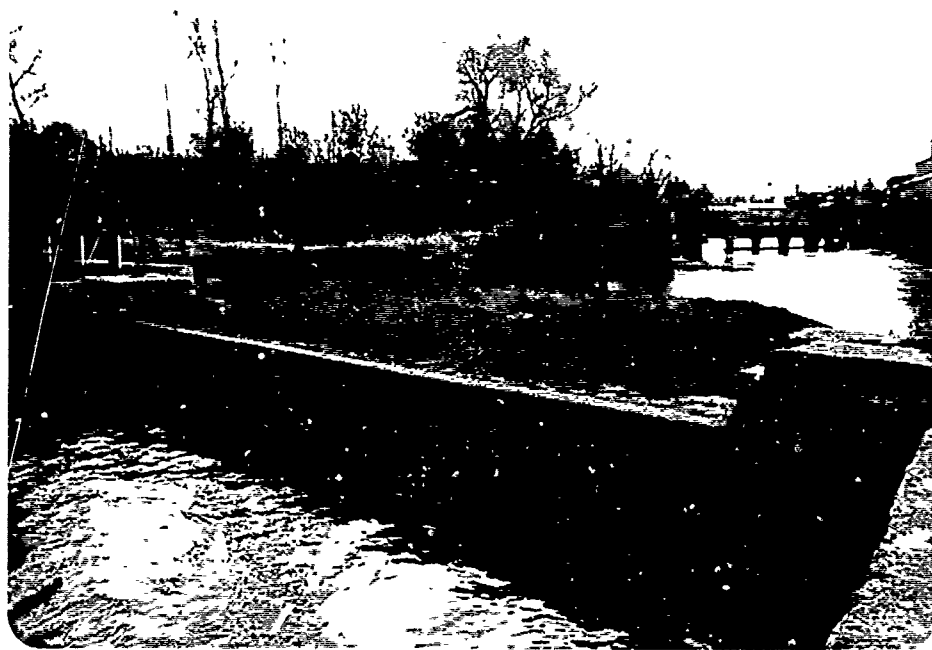
No serious deficiencies were noted on this structure. The embankment portion forming the upstream slope was in satisfactory condition. The masonry and concrete wall which formed the crest of the auxiliary spillway was also in satisfactory condition. An inspection report from 1977 (a copy of which has been included in Appendix D) indicated that there was a small amount of leakage exiting from the base of the masonry wall. This area could not be observed at the time of this inspection due to the tailwater level. Mr. Ryder, the village Utilities Manager, indicated that this leakage has been occurring for a number of years, with no noticeable increase in quantity.

Masonry Wall on Auxiliary Spillway-Slight
Leakage Reported at Base of Wall

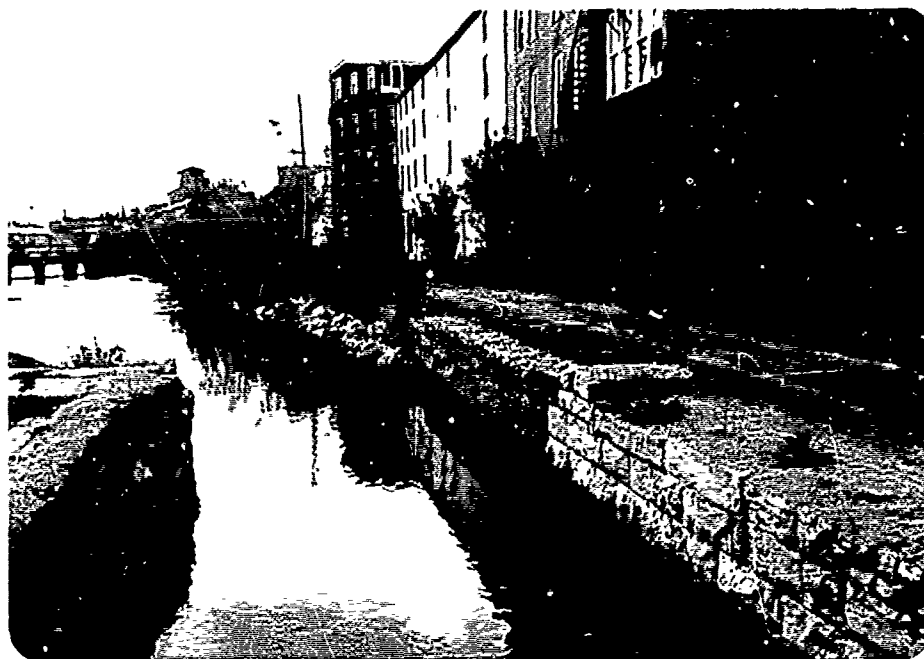
Northern Wall of Approach Channel
Note Gabions and Riprap

- l. Approach & Outlet Channels NORTHERN WALL GABIONS AND
RIP RAP - GOOD CONDITION

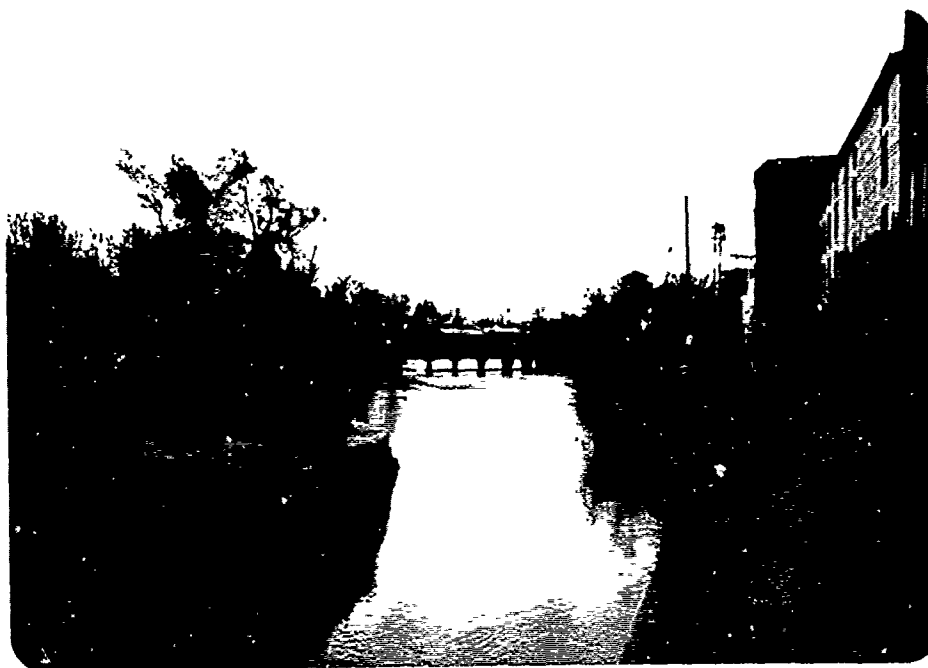
Railroad Bridge Upstream of Dam which
Restricts Flow
